A Total Hygienic Solution - Floor, Drain And Curb Research

Hygienic Design Committee

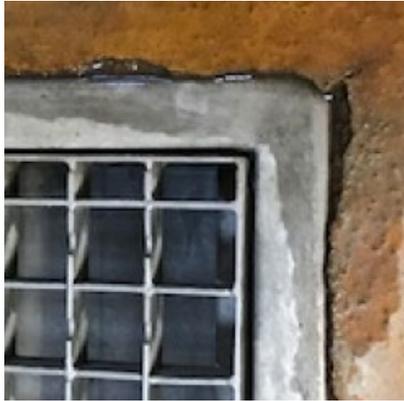
Often starting with a crack in the corner, crevices expand along the side of the drainage.

The EHEDG guideline 44 for Hygienic Design of Buildings considers connections between the drainage and floors to be a very critical spot. Crevices allow for the entry of contaminated water that cannot later be removed. It is impossible to secure against the infiltration and growth of bacteria in such openings.

Guideline 44 offers recommendations on how to reduce this risk. Figure 8.7.10 of the guideline illustrates the recommendation for round shapes on resin floors. Blücher followed this recommendation, constructing a drainage range called HygienicPro®. Years of use in the Food & Beverage market show round drains work better than square drains. To confirm this, the following testing was completed using a HygienicPro +20 round drain.

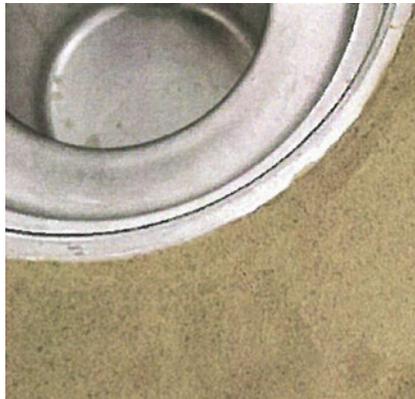
The installation of the round drain was waterproof after the test and no cracks were observed in the flooring material at the drain.

The HygienicPro +20 round drain fastens well to the floor and is a proven, hygienic solution. Sharp corners create vulnerable spots and should be avoided. The round drain recommendations of EHEDG are test-verified. Testing proves that the HygienicPro +20 is a hygienic solution for the edge of channels. Testing confirms that the construction of a round drain is the best connection between a resinous floor and the drainage system.

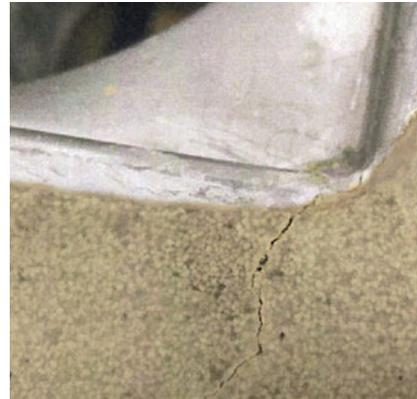
The installation of the square drain was waterproof, but cracking in the surface layer had started.

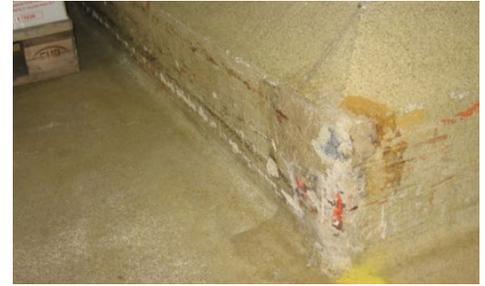
Example of concrete curb with resinous mortar. Signs of impact and damage. Concrete exposed to water will absorb and repel the covering resinous top layer and create a perfect harbor for bacterial growth.

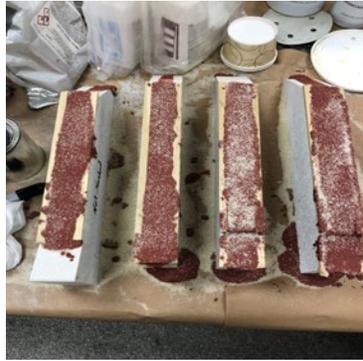
Figure 2: Pull test results for Stonclad UT over Blücher Stainless Steel

- Based on the results recorded in the sections above, all showed very promising bond strengths. The results of Stonclad UT over the Blücher Stainless Steel show high bond strength in all tests. This test also shows that the bond strength of Stonclad UT to all PolySto curbs (natural or sanicoat, prepped or unprepped) is strong.

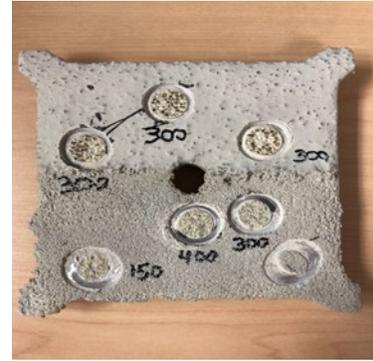
Figure 3: Stonclad UT on Natural and Sanicoat PolySto curbs

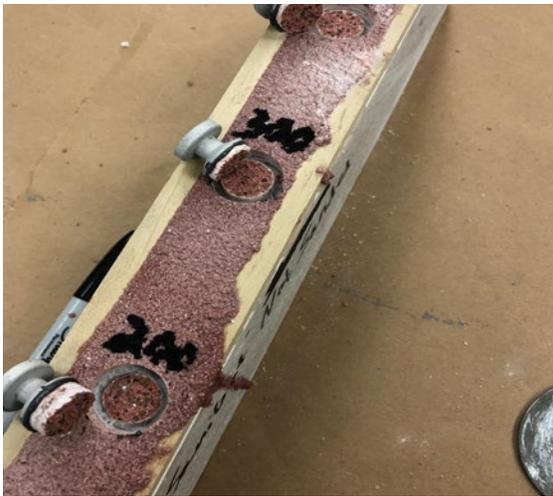
Figure 4: Pull test results for Stonclad UT over PolySto Natural unprepped

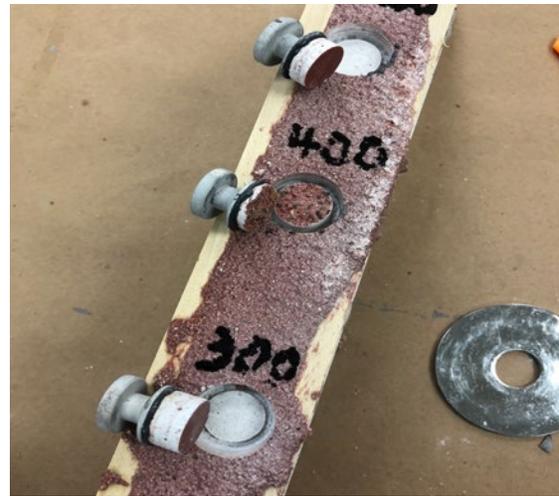
Figure 5: Pull test results for Stonclad UT over PolySto Sanicoat unprepped

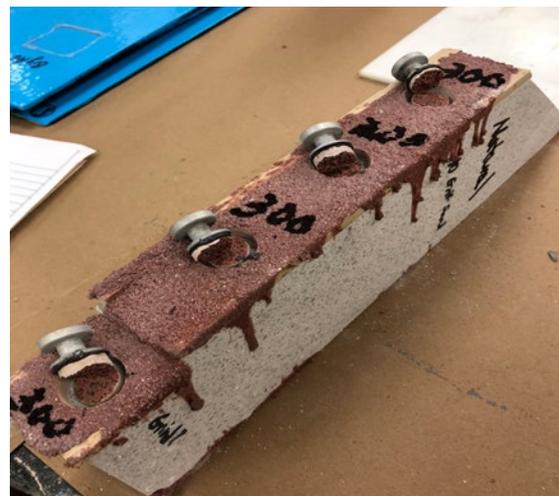
Figure 7: Pull test results for Stonclad UT over prepped PolySto Sanicoat
